Analysis of Yellow Brick Recovered at Manlick Farm Site

Olivia Schomer

Department of Anthropology, St. Cloud State University

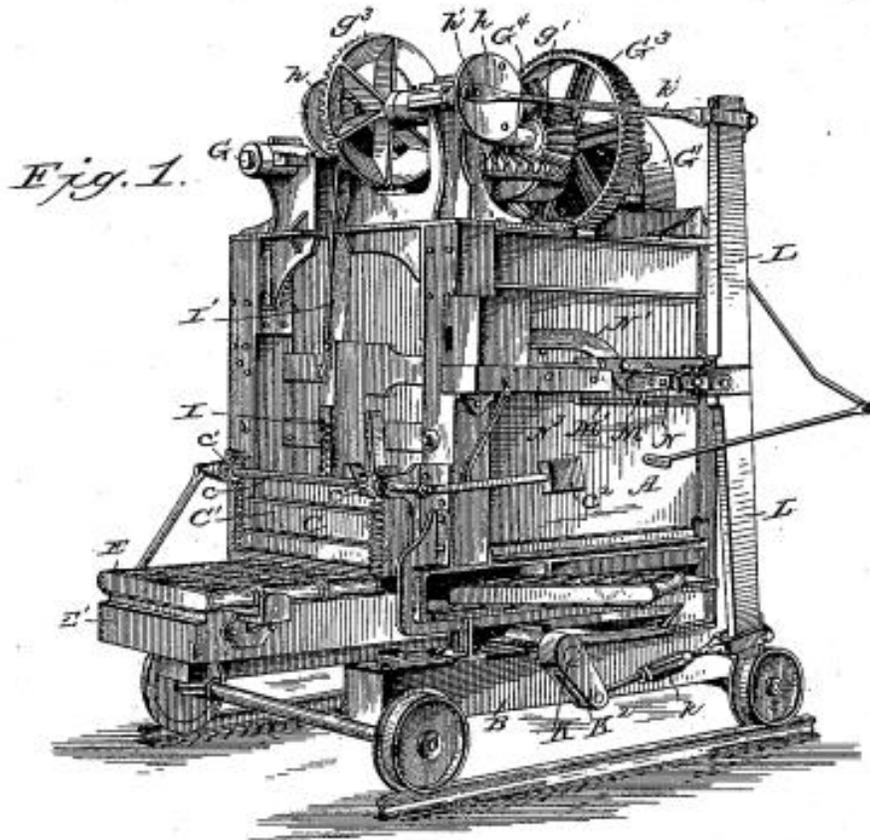
Figure 1: Bierline Brick Machine Patent Model

Minnesota is known for its yellow brick, sometimes referred to as “Chaska” brick because much of it originated from Chaska, Minnesota. In fact, one of the first brick machine patents in Minnesota was filed from Chaska (see Figure 1). This patent was filed by Michael Bierline in 1891, which would improve the manufacturing process of the “Chaska” brick, which is a unique and diagnostic type of brick for Minnesota (Bierline 1892). According to the National Register of Historic Places (NRHP), Chaska brick “is a cream-colored, common brick that was produced for 100 years, from 1857-1961, in Carver County” (USDI: NPS 2013). This brick was the main type of brick in the state of Minnesota during this time period and the brick was made for the towns of Chaska and those in Carver County but was also used by other cities in Minnesota. According to the National Register of Historic Places, “while Chaska brick was exported to the Twin Cities, a significant amount was used by area residents to build houses,

M. BIERLINE.
BRICK MACHINE.

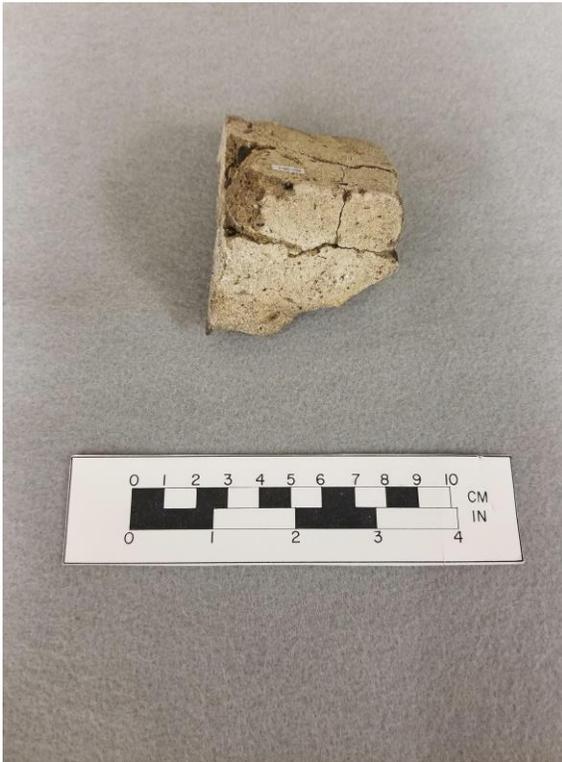
Figure 2: Brick recovered from Transect 9

One of the bricks from transect 9 was a lighter color than the rest of the bricks recovered. This brick was an outlier, possibly as a result of being burned, due to the lighter color on the outside (See Figure 2) and a darker, almost dark brown shade on the inside (See Figure 3 and 4). The inclusions in this brick were also odd. While most of the bricks recovered had inclusions that were a variety of red to light brown, the brick from transect 9 had black and dark brown inclusions (see Figure 4). Another outlier, in terms of inclusion color, was the brick recovered from transect 6, which had a single white inclusion. Based on the information regarding the type of material that bricks included in Minnesota, we can interpret the red to light brown inclusions to be a type of clay found in Minnesota, which was also included in Chaska brick at the time. The black inclusions might have been due to possible exposure to fire, and the white inclusion

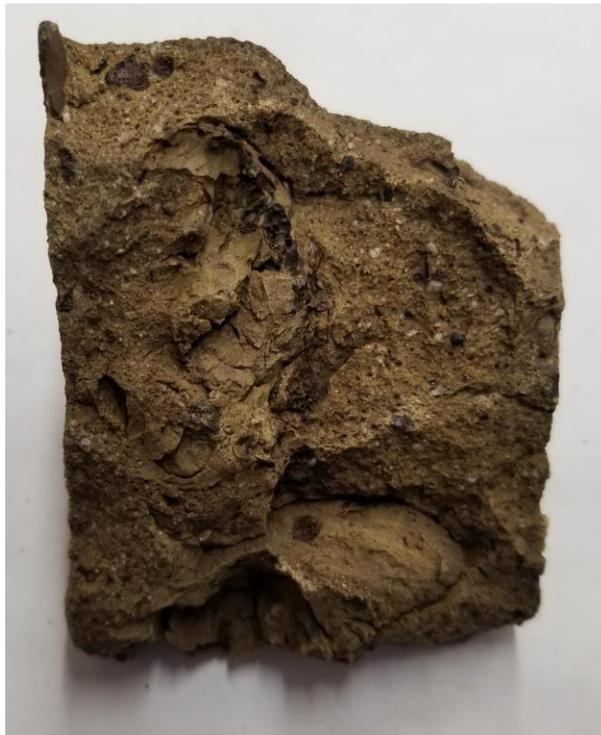
Figure 4: Close up photo of inside of brick from Transect 9, not to scale

could have been a manufacturing error as it is unusual for manufacturers to include white inclusions, especially the Klein Company of Chaska.

Based on the evidence presented above, the assumption can be made that the brick found at the Manlick Farm site in Belle Prairie, Minnesota, is Chaska brick. The origin of the brick is evidenced by the color of the bricks recovered, ranging from a yellowish cream to a pale brown to a slight pink or salmon color, which is diagnostic for Chaska brick. Although firebrick tends to have this same coloring, the inclusions, except for one brick, indicate that the bricks were not fired again after the manufacturing process. The one brick, from Transect 9, which had a lighter variation of the yellowish-brown color, is thought to be a brick that was exposed to fire after the manufacturing process, which is also evidenced by the fact that the inclusions within the brick were black or dark brown in color, differing from the typical inclusions which were a red or reddish brown.
